PSC연구모임 설정과제

Varina-Enon Bridge 사례연구를 통한 결함부 그라우트 충전 보수의 적합성 고찰

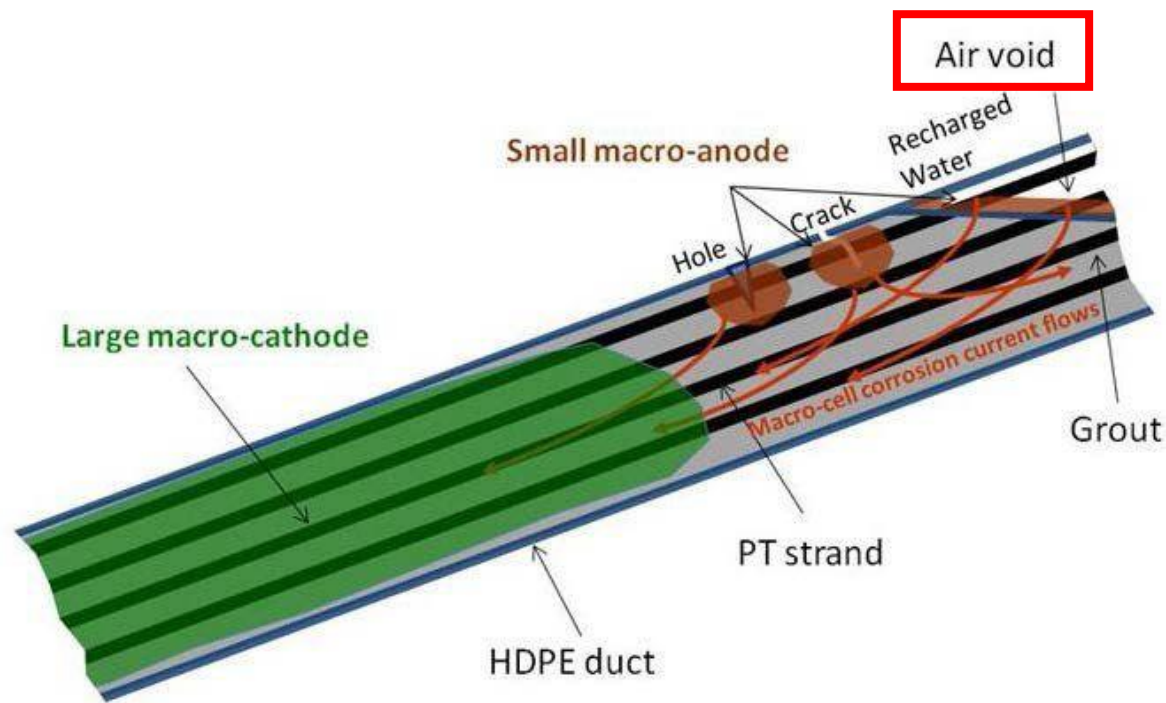
Macro-cell corrosion mechanism in PT tendon

- ✓ 텐던의 정착부, 덕트 최상단은 블리딩 등에 의해 대규모 공극이 발생할 가능성이 높음
 - 회색부분: 작은 규모의 양성전위 (macro-anode)
 - ▶ 공극 및 균열부에서 공기, 수분, 염화물 등에 노출
 - ▶ 중성의 습한상태
 - 초록부분: 큰 규모의 음성전위 (macro-cathode)
 - ▶ PH가 높은 염기성 환경과 건조한 상태
- ✓ 대규모 공극에 의하여 발생하는 큰 전위차는 양성 (Anode)인 부분에서 부식을 급격하게 발생시킴

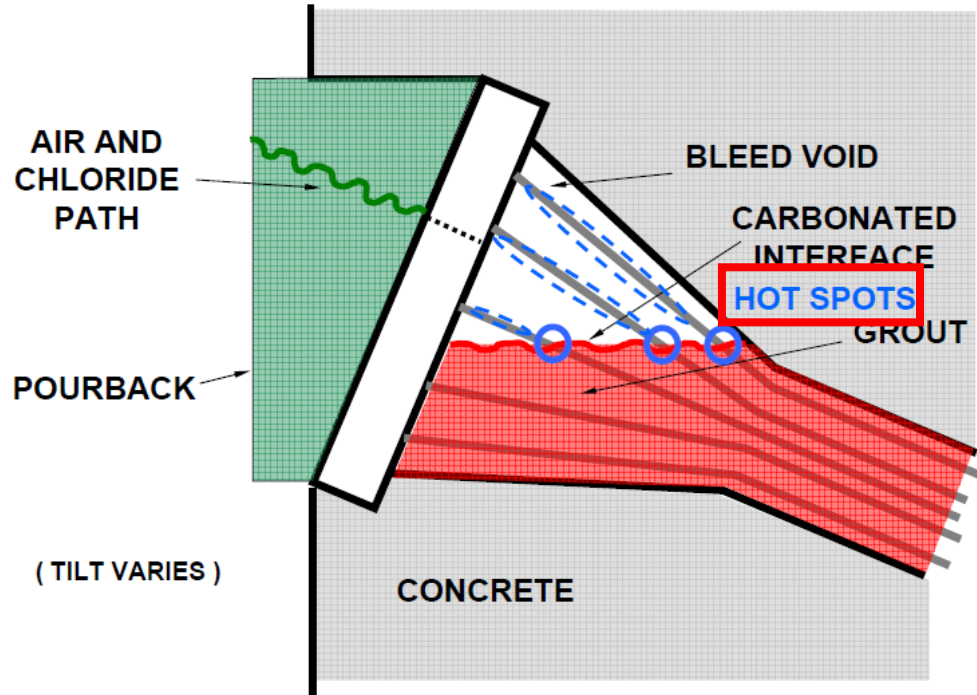
Aggravation by Galvanic Coupling

- The bulk grout-void interface is electrochemically coupled to the rest of the passive strand and anchor metal.
- After passivity breakdown, oxygen reduction at those large surfaces can intensify corrosion at the steel emergence point.

- ✓ 공극으로 기인하여 부동상태가 깨지게 되면 산소 환원에 의한 HOT SPOTS에서 부식이 집중됨

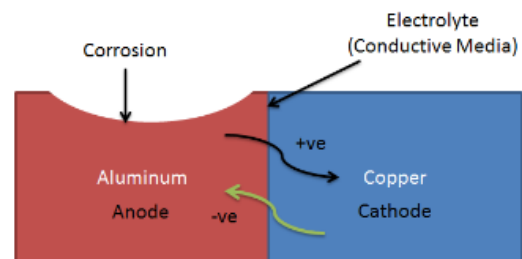
<Galvanic corrosion cell>

Hansen (2007) reported that the location of tendon failure was at the interface between the existing Class A or B grout and newer Class C repair grout. This failure indicates a critical need for research into the influence of new repair grouts on tendon corrosion, especially at the interface between existing and repair grouts. This interface could possibly generate a galvanic corrosion cell. However, the validity of this argument needs to be investigated. It was also observed that many tendons were not completely sealed during the original construction. This likely enabled moist air from the environment to enter the voided ducts and accelerate corrosion of the exposed tendons.

- 텐던 파단이 기존/보수 그라우트의 경계면에서 발생
- 경계면에서 보수 그라우트가 텐던의 부식에 미치는 영향에 대한 연구가 필요함
- Galvanic corrosion cell의 발생시켰을 가능성이 있으나, 이러한 주장의 입증은 추가 조사가 필요함

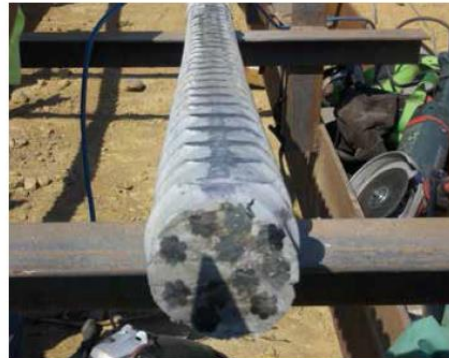
Grout 2 tendon has void along top.

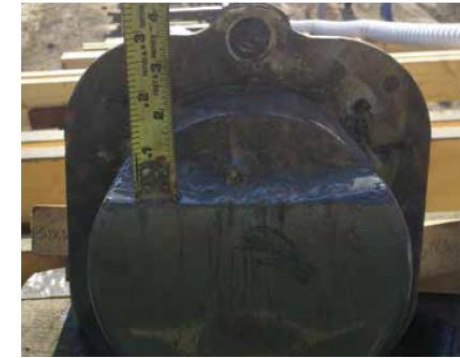
Grout 2 outlet end cap has void and soft grout.

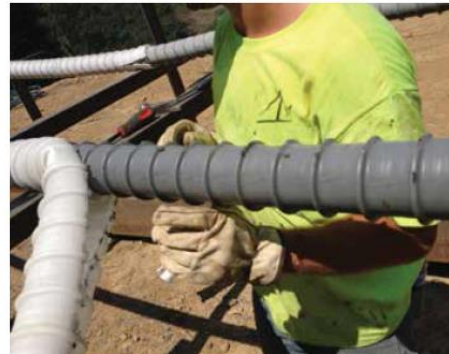
Grout 3 tendon is fully grouted.

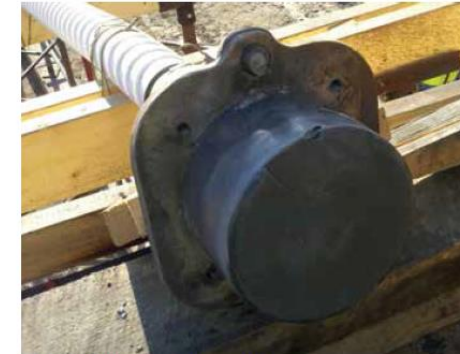
Grout 3 outlet end cap fully grouted.

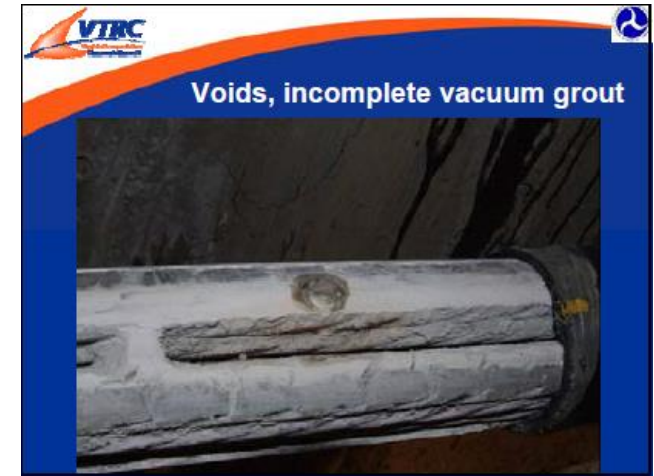
Transverse Tendon Failure May 2017

- ✓ 기존 저품질의 Water-cement Grout는 부식 유발
 - 불리딩, 재료분리, 높은 수분을 함유, 많은 공극 유발
 - ⇒ 텐던의 약 55%를 진공그라우트 충전
 - 텐던의 기밀성이 떨어지는데 **진공그라우트로 잘 충전 되었을지 의문?**
- ✓ 보수 그라우트(Prepackaged HPG)의 재료적 적합성 추측
 - VE교에서 보수로 사용한 grout2를 US460의 목업테스트결과 **Rejected**
 - Sika300PT(Grout2)가 사용되었을 가능성
- ✓ **파단의 원인으로 Macro-cell부식 매커니즘을 명시하고 있지 않음**
 - 가능성에 대하여 언급
- ✓ **횡방향 텐던 파단 발생 (2017년 5월)**
 - 2개 cable stay 경간의 Transverse deck tendon
