미국연방도로청 PT 텐던 연구프로그램 - 12년의 과정과 결과 소개

Seung-Kyoung Lee, Ph.D.

SK Lee & Associates, Inc.
Fairfax, Virginia, U.S.A.

서울시설공단
2020년 6월 30일

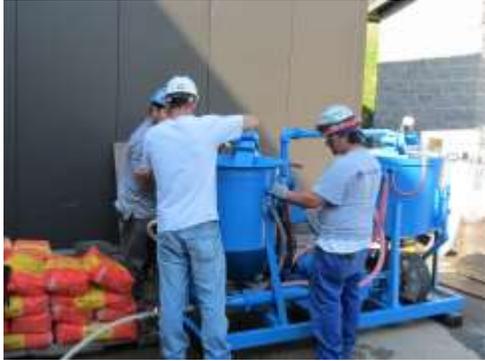
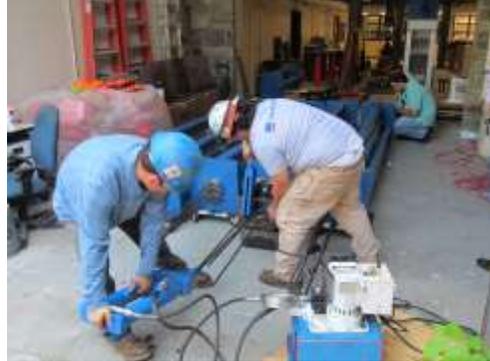
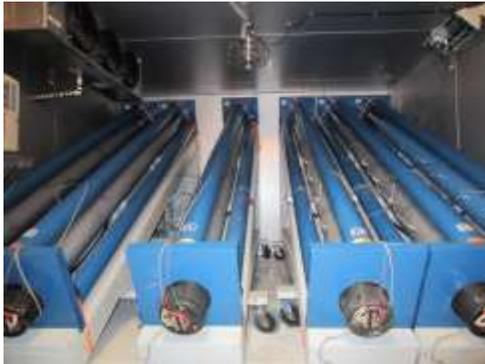
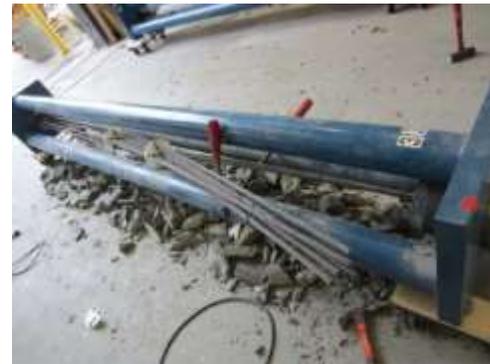
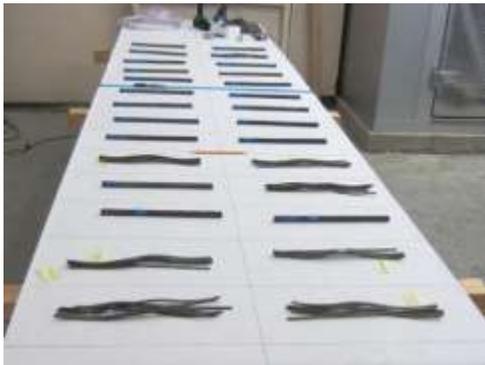
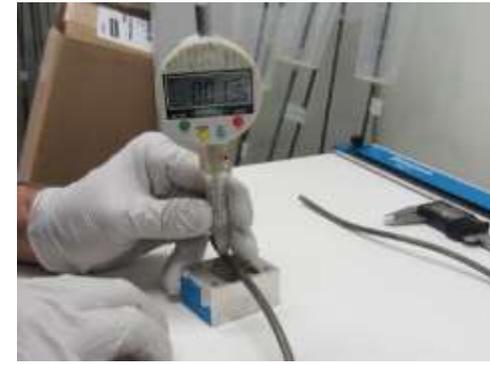
Figure 35. Illustration. Task 2.3 multi-strand specimens.

Number of Specimens

- Stressed Specimens @ 60% GUTS: 8 EA (Chloride concentrations: 0, 0.08, 0.2, 0.4, 0.6, 0.8, 1.0, and 2.0 % by weight of cement)

정상적인 그라우트에서 부식개시에 필요한 염화물 농도는 시멘트량을 기준으로 0.4%; 활발한 부식진행에 필요한 염화물 농도는 0.8%.

결함이 있는 그라우트에서는 결함의 특성과 정도에 따라 크게 낮아질 수 있음.

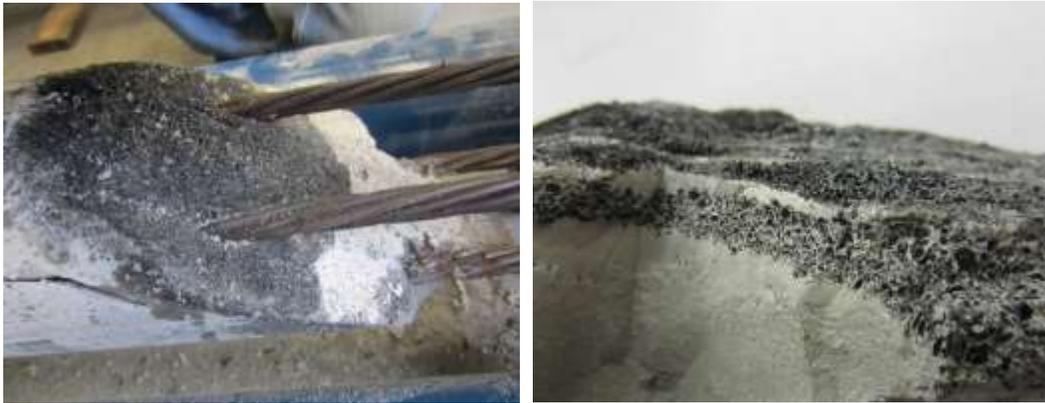
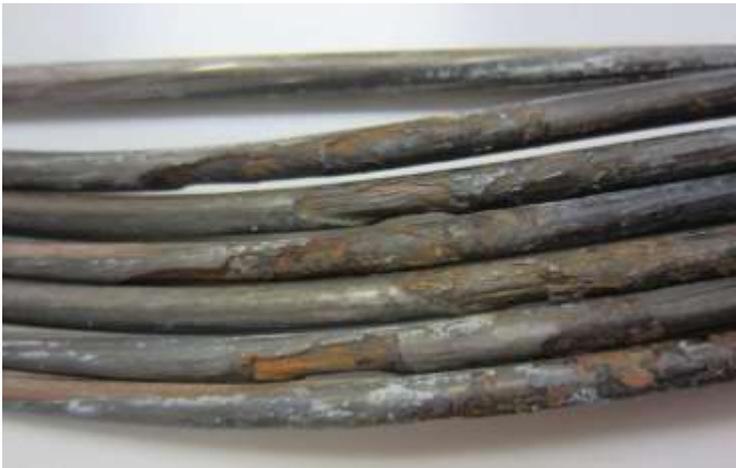
그라우트 재료분리로 인한 황산염의 부식 유발

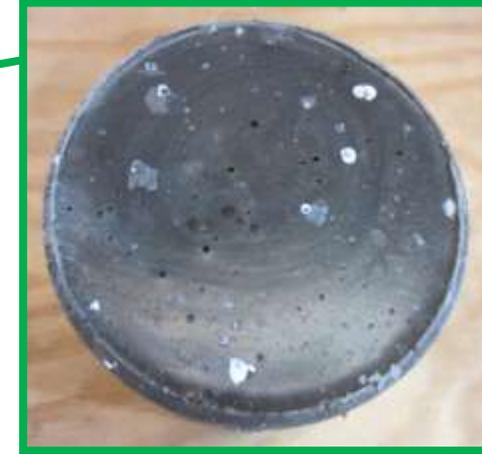
[Product 1 - normal]

그라우트 타입과 위치별 수용성 황산염의 농도

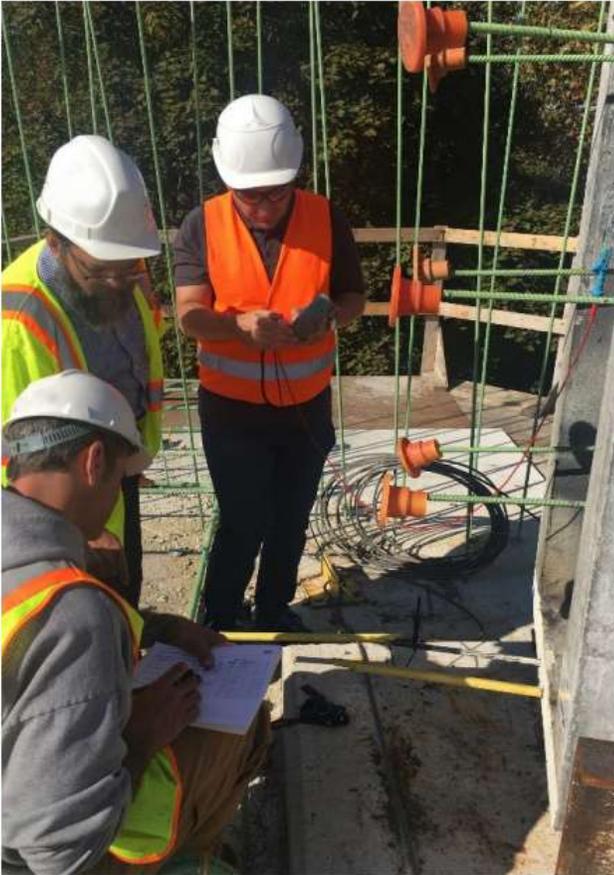
The main advantage of EIT systems is the ability to non-destructively monitor tendon encapsulation over time. In the photo above, initial construction reading is collected.

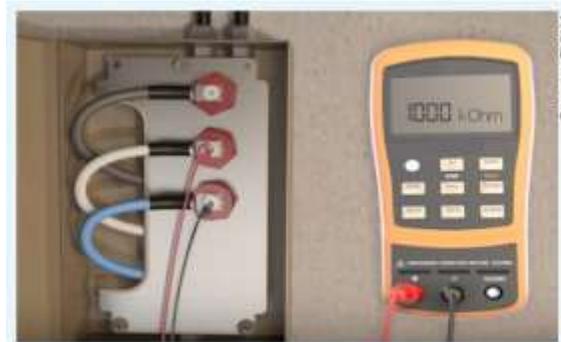
By measuring the AC impedance between the tendon and the reinforcing steel, bridge owners can assess the quality of the EIT encapsulation.

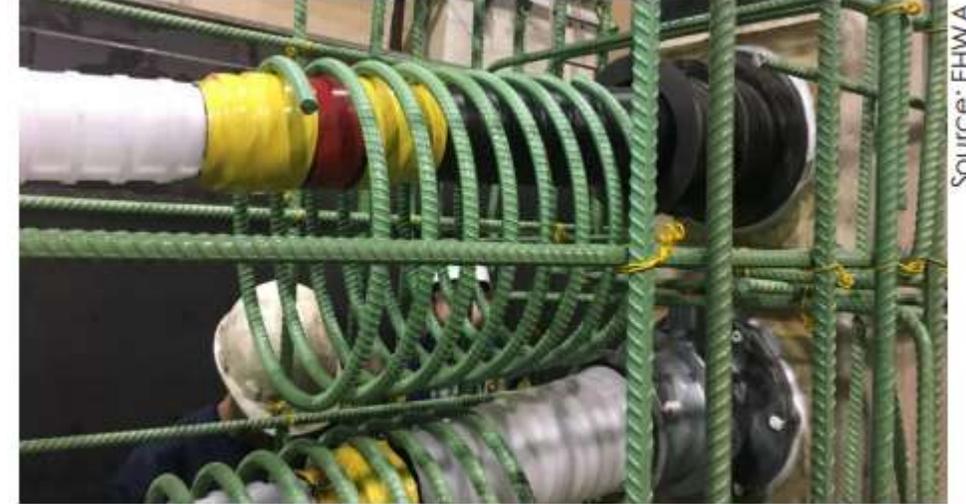
The EIT system has no macro-cell interaction with the reinforcing steel.

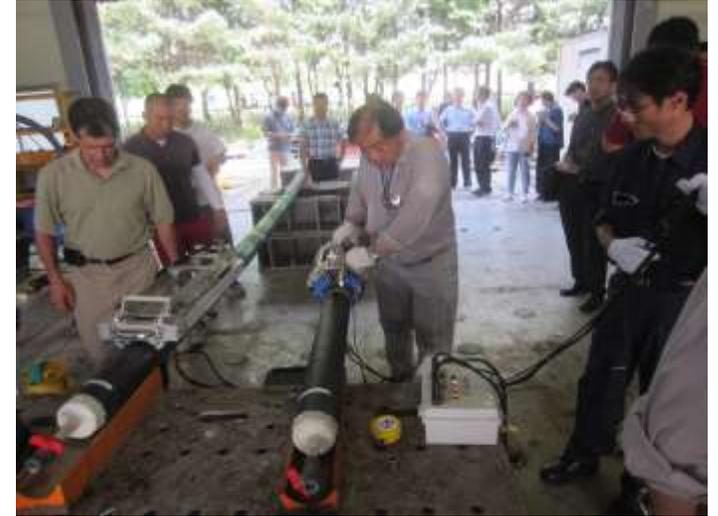
[1차 테스트, 2016년 8월]

1차 블라인드테스트 결과(부식 단면결손)

업체	탐사법	인위손상 (N)	탐사개수(M)		유효율 G/M (%)	위치정확률 G/N (%)	RMS	현장적용성
			G	PG				
B	MMFM	24	26(22)*		61.5 (72.7)*	66.7	3.25	◎
			16	0

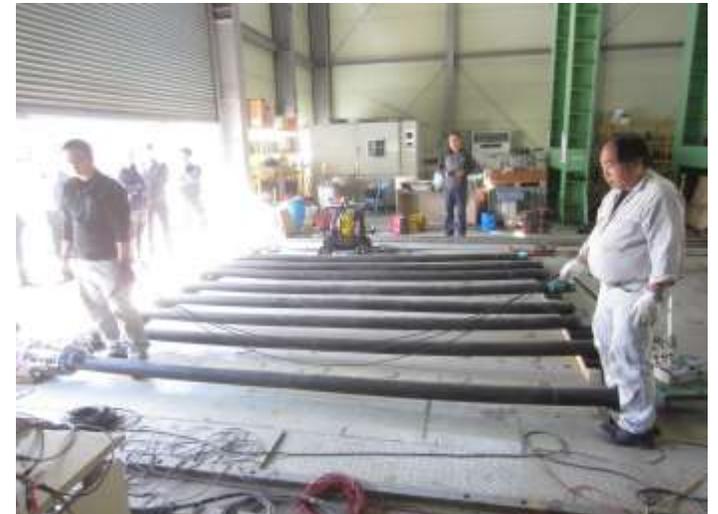
[2차 테스트, 2017년 7월]

2차 블라인드테스트 결과(부식 단면결손)

업체	탐사법	인위손상 (N)	탐사개수(M)		유효율 G/M (%)	위치정확률 G/N (%)	RMS	현장적용성
			G	PG				
B	MMFM	24	27(23)*		81.4 (95.7)*	91.7	1.78	◎
			22	0

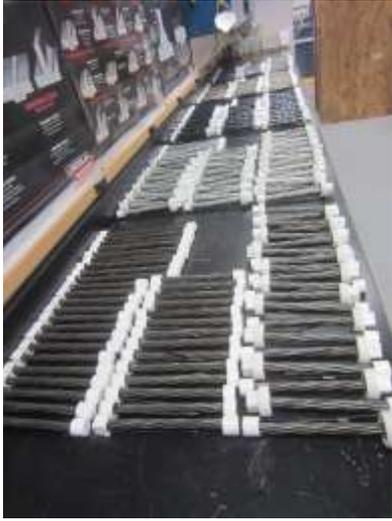
[Aqueous Solution Testing]

1. ASTM A416 Bare Strand
2. Hot Dip Galvanized Strand
3. Zinc Alloy Coating Strand
4. Flow-Filled Epoxy Coated Strand
5. 2205 Duplex Stainless Steel Strand

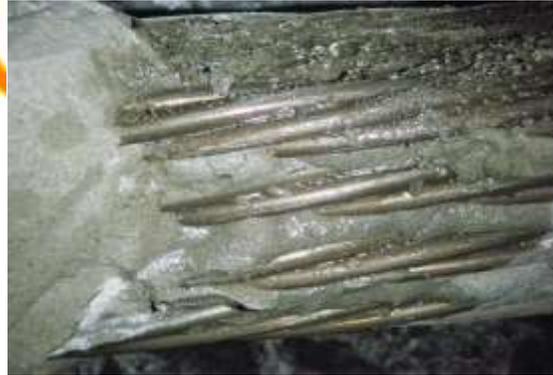
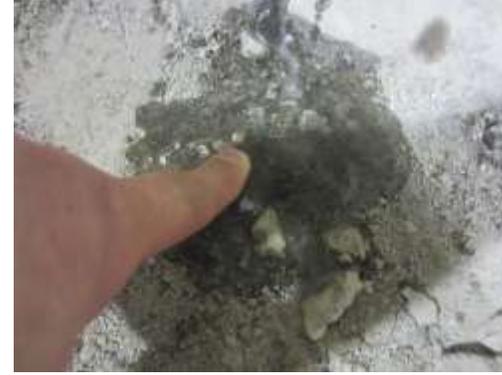
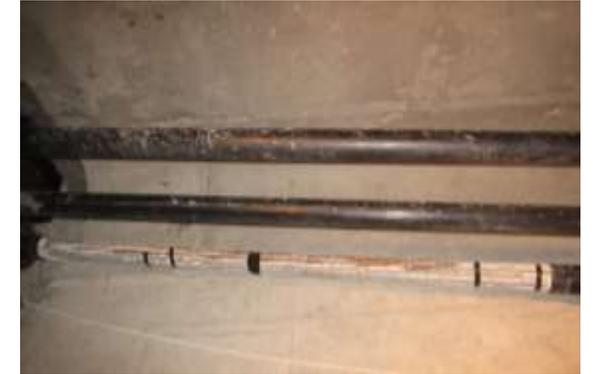
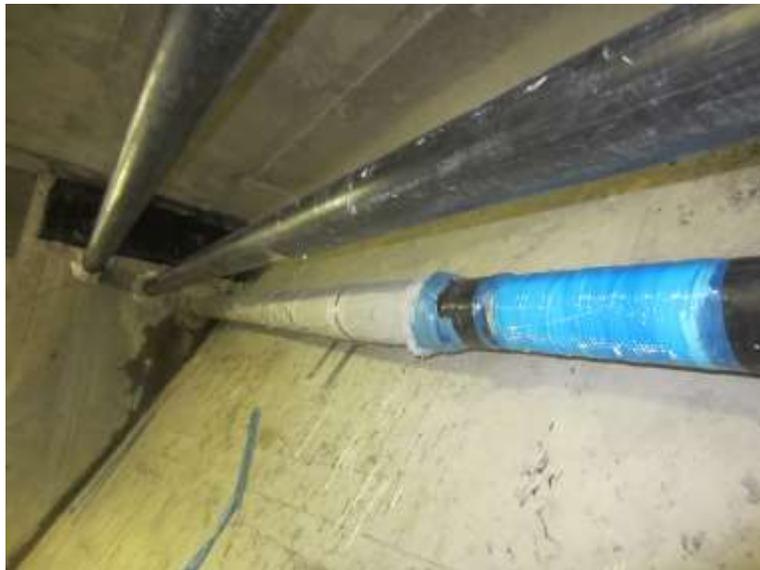
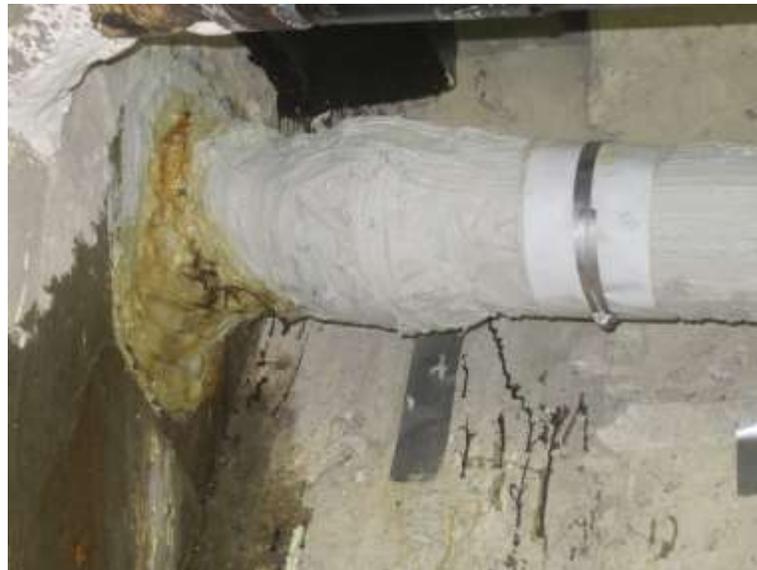
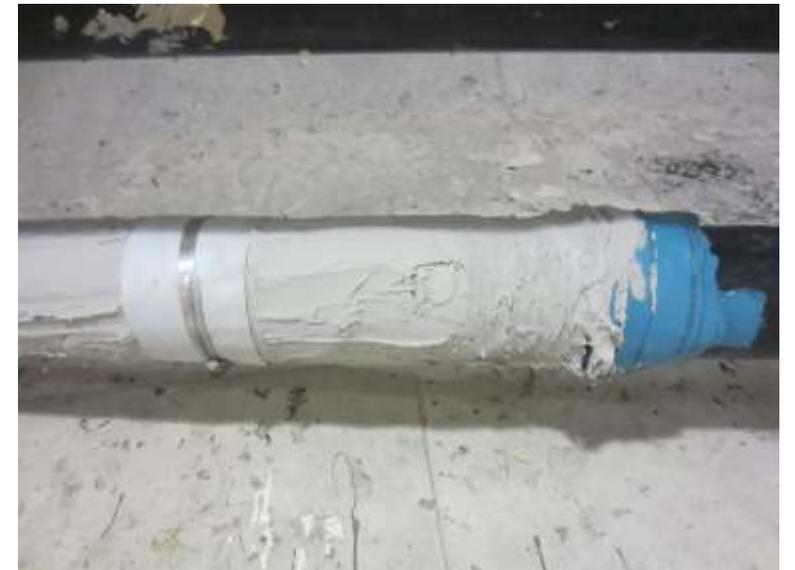
Impregnation Method (FDOT, VDOT)

VDOT data (July 2015): \$12,222 per tendon (mobilization for \$3,947 and injection for \$8,275)

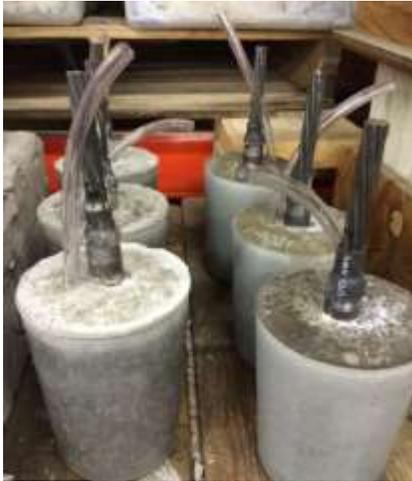
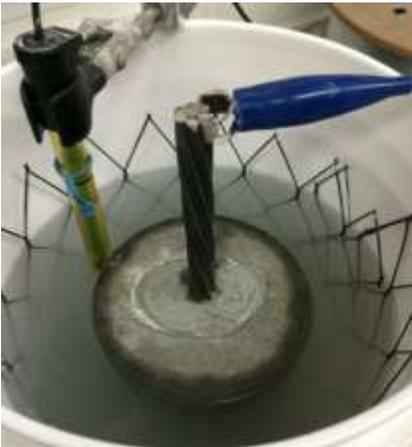
Impregnation Method (Vendor Data)

“Prior to completing impregnation, the moisture content of the strands was tested to ensure the strands, voids and grout was not saturated with water. As a result, drying of the strands and surrounding grout was not required prior to impregnation.”
