PSC연구모임 설정과제

Varina-Enon Bridge 사례연구를 통한 결함부 그라우트 충전 보수의 적합성 고찰

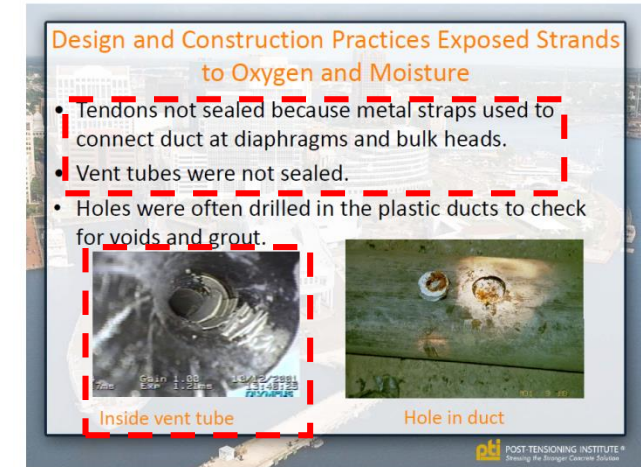
〈2014년 PTI 발표자료〉

bleed and segregate after being pumped into a tendon. A wick-induced bleed test indicates that bleeding in grouts used prior to 2001 was approximately 4%. In a typical 150 ft (45.7 m) long tendon in the Varina Enon Bridge (Fig. 4), 4% bleeding can cause 6 ft (1.8 m) of void at the high points in the draped tendons and a void along the top of a horizontal tendon (Fig. 5). Six of the eight tendons in

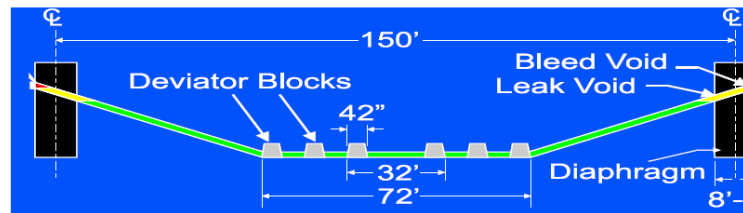
〈2017년 VCC 발표자료〉

Typical Grouted Condition of Draped Tendons (1)

- Grout bleeds and segregates leaving 2 voids, each approximately 2 per cent of the tendon length.
- For 150-ft tendon two 3-ft voids with un protected strands at anchors is typical (red in figure).
- **Preservation:** NDE methods can not be used to evaluate the condition of the strands. Install acoustic emission monitoring system to detect wire breaks.

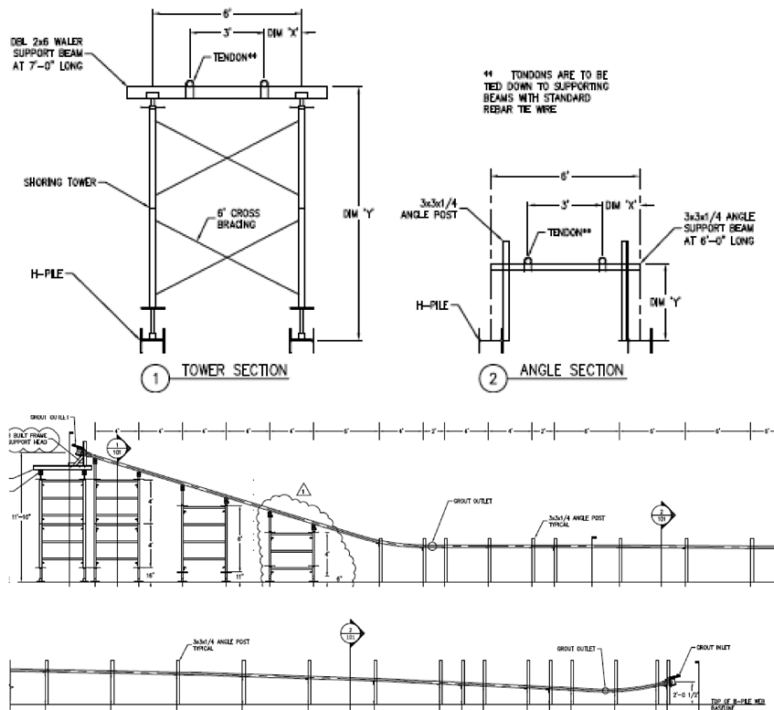
In 2012, VDOT did a mockup by work order to identify a suitable grout for use in the US 460 segmental bridge project near Grundy, VA. The mockup determined that Grout 3 was suitable for use because the tendon was properly grouted. Grout 2 bled and segregated and left voids and soft grout at the high points in the tendon in the mockup and was rejected for use.

Grout 2 tendon has void along top.

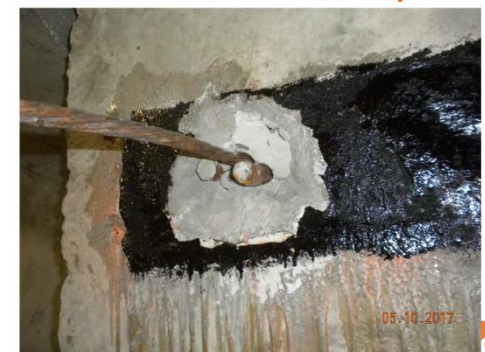
Transverse Tendon Failure May 2017

- ✓ 기존 저품질의 Water-cement Grout는 부식 유발
 - 불리딩, 재료분리, 높은 수분을 함유, 많은 공극 유발
 - ⇒ 텐던의 약 55%를 진공그라우트 충전
 - 텐던의 기밀성이 떨어지는데 **진공그라우트로 잘 충전 되었을지 의문?**
- ✓ 보수 그라우트(Prepackaged HPG)의 재료적 적합성 추측
 - VE교에서 보수로 사용한 grout2를 US460의 목업테스트결과 **Rejected**
 - Sika300PT(Grout2)가 사용되었을 가능성
- ✓ **파단의 원인으로 Macro-cell부식 매커니즘을 명시하고 있지 않음**
 - 가능성에 대하여 언급
- ✓ **횡방향 텐던 파단 발생 (2017년 5월)**
 - 2개 cable stay 경간의 Transverse deck tendon
