해외기관 교류내용 및 추가자료

기술혁신센터

Outline

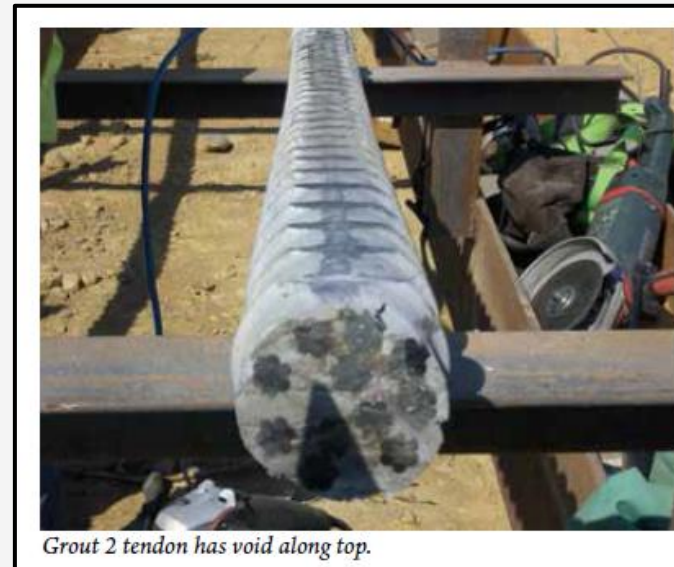
Mock-up test

0.65. Results were quite interesting. As the w/b increased, Grout 1 exhibited diminished properties; Grout 2 bled, segregated, and produced soft grout in increasing amounts; and Grout 3 produced a lower-strength foam in increasing amounts. Results are pictured in Fig. 13 and 14. Figure 15

w/b (물/결합재비)가 증가함에 따라

- 그라우트 1은 감소된 특성을 나타냄
- 그라우트 2는 블리딩, 재료분리, 소프트 그라우트를 증가 (soft그라우트는 황산염 함량이 높고 부식성이 매우 강함)
- 그라우트 3은 저강도 foam을 발생

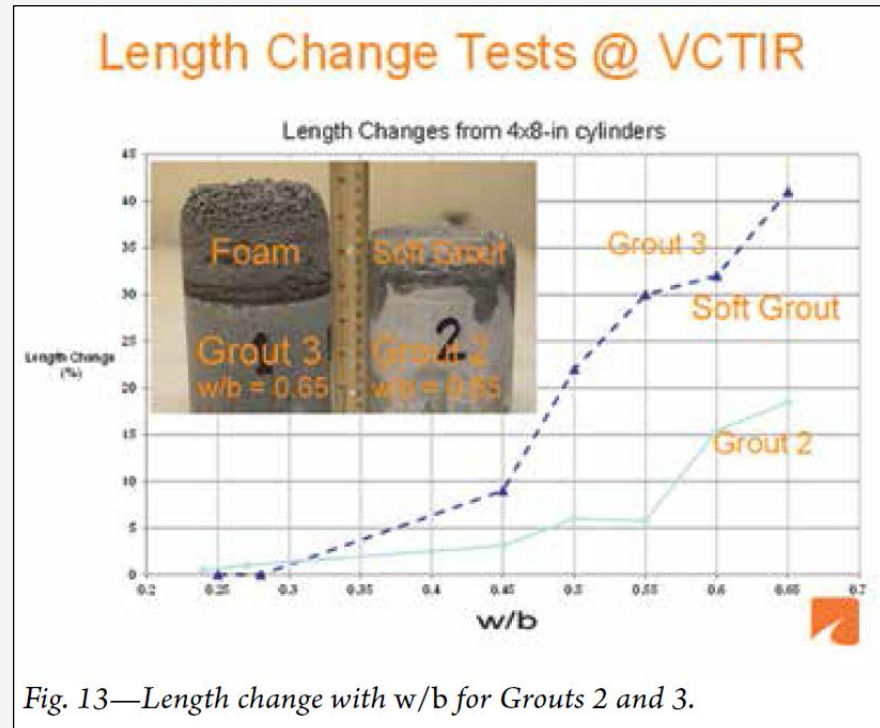
The mockup revealed that Grout 2 was not acceptable for use. Grout 2 produced voids along the top of the tendon and at the end caps and left soft grout that never set at the end caps (Fig. 11 and 12). The soft grout had a high sulfate content and is very corrosive. Grout 3 performed exceptionally well and fully grouted the tendon. Grout 3 was used to grout the bridge.

- Grout2는 텐던의 상단과 end캡을 따라 공극을 만들고, end캡에 soft그라우트를 남김 → 부적합
- 그라우트 3은 품질이 좋고 텐던을 완전히 채움
